# AIRMUNITIONS LETTER

OCAMA AIRMUNITIONS LETTER  
NO. 136-11-56C

SUBJECT: Advance Explosive Ordnance Disposal Technical Information

SUMMARY OF NUCLEAR WEAPONS INCIDENTS (AF FORM 1058) A/D  
RELATED PROBLEMS JUNE 1960

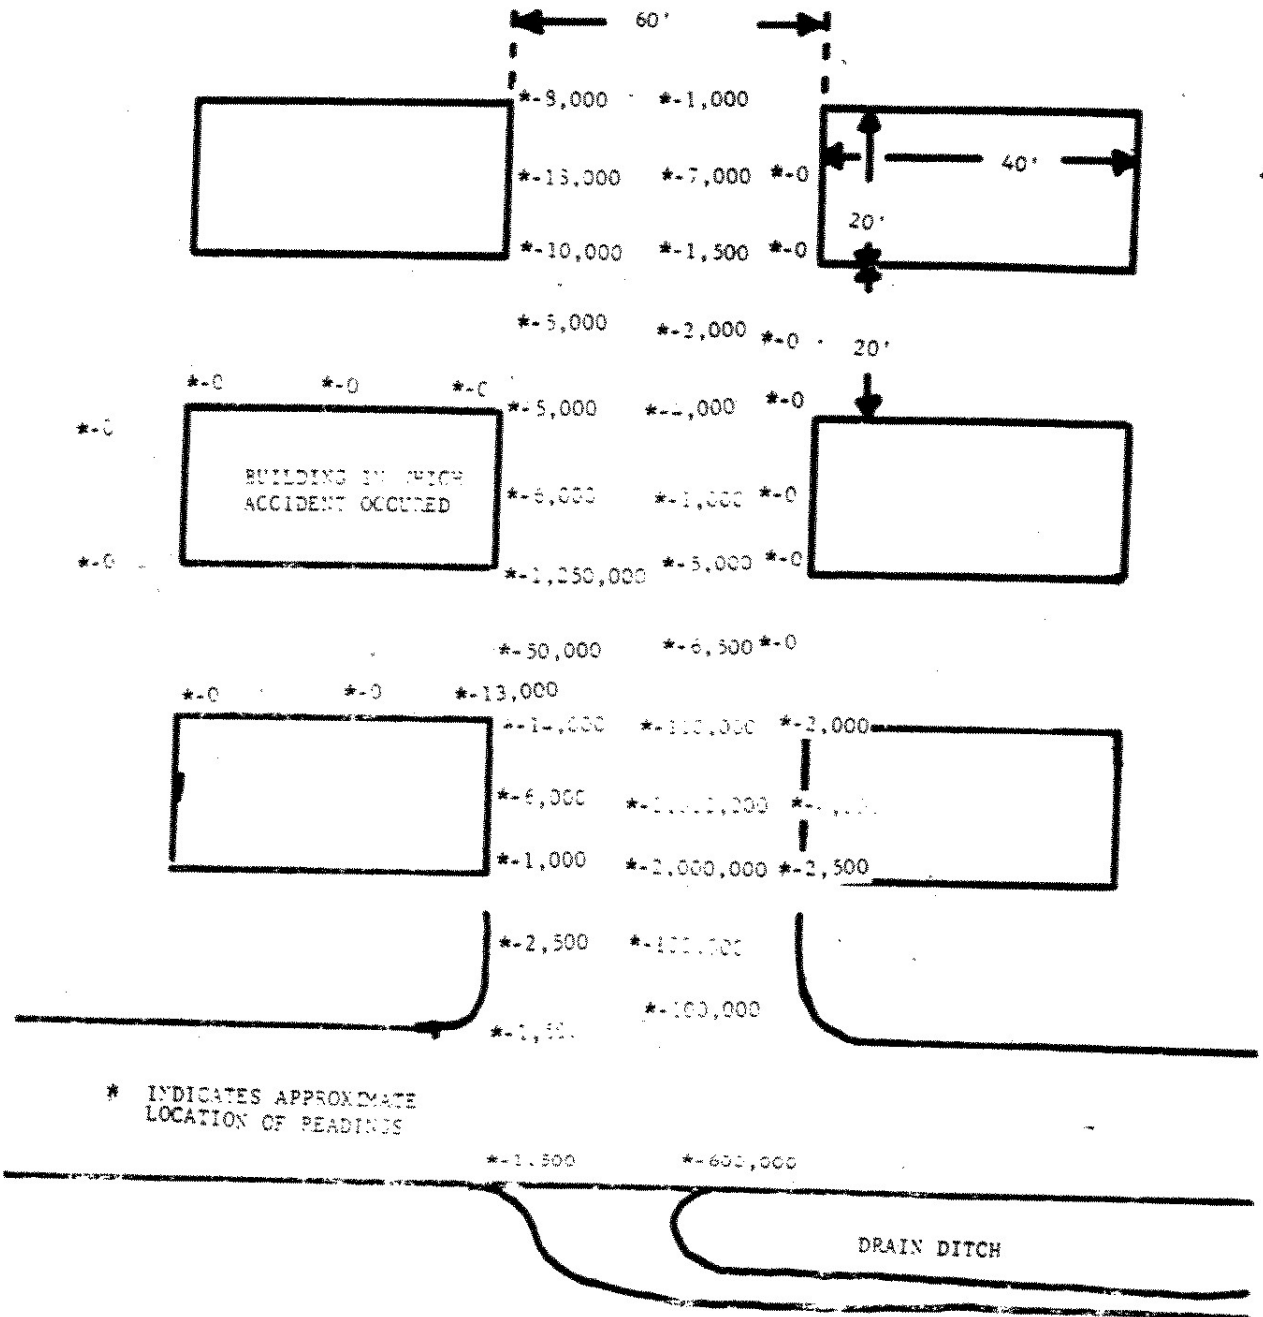
FIGURE 2. Monitoring Survey Results, 10 June 1960.

(6) On 10 June the entire area was again surveyed. It was found that during the fire tar had melted and had solidified in sections of the floor in thin layers. Several of the readings were in the range of over 2,000,000 CPM. The clean area showed zero (0) readings. The center of the road in front of the shelter also raised in contamination reading to 2,000,000 CPM (2.) The entire area was again washed down and allowed to dry. A remonitored a slight drop in contamination was found, but the roadway was still over the allowable limits. After the area completely dried, the inside of the shelter was painted. A very thick layer of paint was applied. The outside of the shelter was painted, using brooms to spread the paint. A total of

10 JUNE  
1000 HOURS

ALL READINGS ARE IN COUNTS  
PER MINUTE
